GROUP 1 TEST REPORT

SOLDER STUDY CONDUCTED ON APOLLO TELESCOPE MOUNT  
GYRO PROCESSOR

Contract No. NAS8-11684

MARTIN MARIETTA CORPORATION

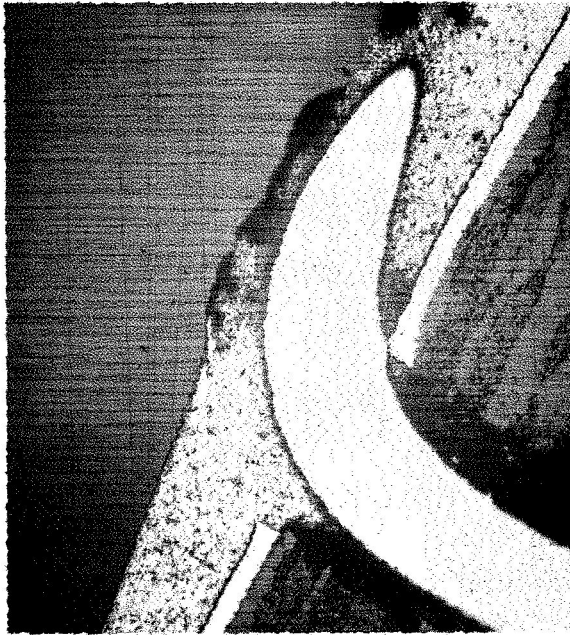
Figure 4. Typical Joint with 60/40 Solder and Nickel-Iron Lead after 3936 Cycles from  $-100^{\circ}\text{F}$  to  $+200^{\circ}\text{F}$

Photomicrographs A, B, and C in Figure 4 are typical of solder joints with 60/40 solder and a nickel-iron lead after only 3936 thermal cycles from -100°F to +200°F. Note in "A" how the solder has developed a lumpy appearance. Photograph "B" is a view of a further cut; both "A" and "B" are at 50 power magnification. The view of "C" is at 500 power magnification at the point in "B" shown by the arrow. Note that there is a good bond between the solder and the lead.

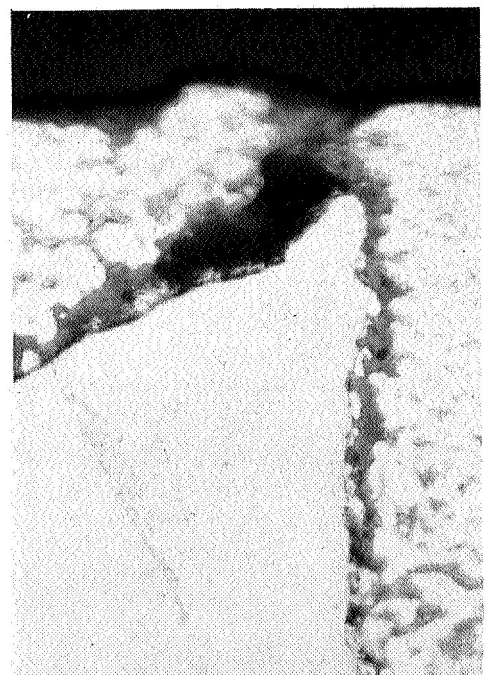
Figure 6. Lengthwise Section of Solder Joint with Relay Pin and Copper Tubelet after 3936 Cycles from  $-100^{\circ}\text{F}$  to  $+200^{\circ}\text{F}$

Figure 6 shows photomicrographs of a relay pin with a crimped, welded, flanged tubelet sectioned lengthwise at two areas to illustrate the second typical type of cracking that occurs during 3936 thermal cycles

on the accelerated testing machine. Note that the cracking is very localized and superficial. Photograph "A" shows only the tubelet; note the crack in the solder in the hole section of the PC board at 50 times magnification. Photograph "B" shows the central cross-section of the relay pin, tubelet, and solder. Note that the arrow at the end of the pin shows a crack that occurred where the pin was clipped off. Photograph "C" is a magnified (500 times) view of the bond between the relay pin and the solder showing that a good metallurgical bond existed. Photograph "D" is a 500 times magnification that shows the extent of the localized cracking where the relay pin was clipped off; this is a typical crack.
